EXPERT FILE REVIEW AND ANALYSIS REPORT

EFI Global File No.: 026.01915 May 19, 2021

Vehicle Fire

United States v. Jackson Patton 200 East 400 South Salt Lake City, UT 84101

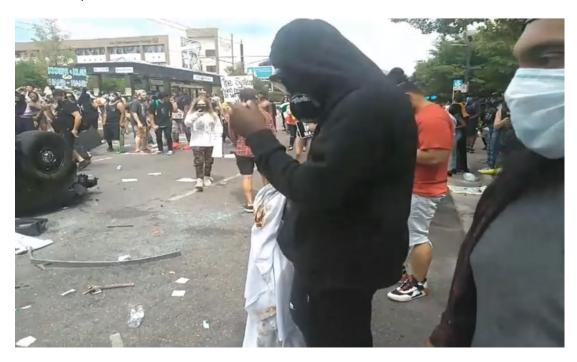
Image 2: Male individual in black hooded sweatshirt holding burning material. Screenshot from Juniper Toxic video.

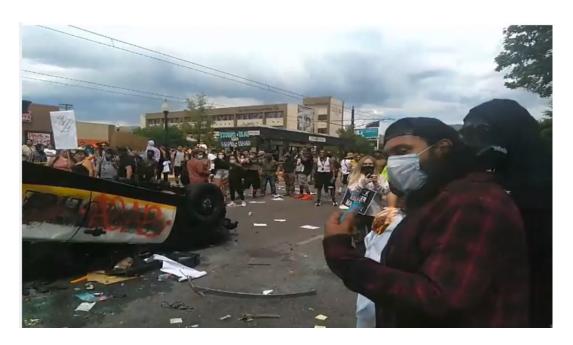
Image 3: Male individual wearing plaid shirt holding lighter used to ignite material. Screenshot from Juniper Toxic video.

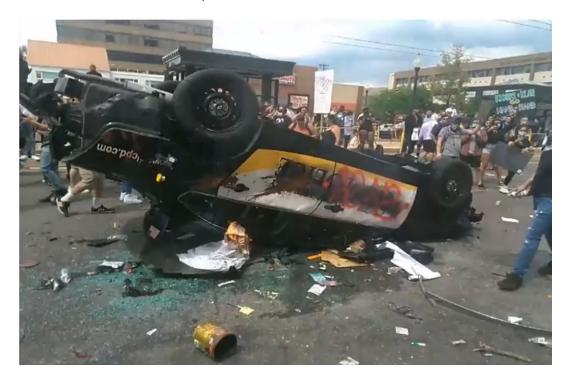
The fire originated in the rear of the passenger compartment of the vehicle after it was pushed onto its top. The vehicle was vandalized by several people. The fire occurred when burning material was placed in or near the broken window in the driver's side rear door.

Image 4: Burning material at driver's side rear window. Screenshot from Juniper Toxic video.

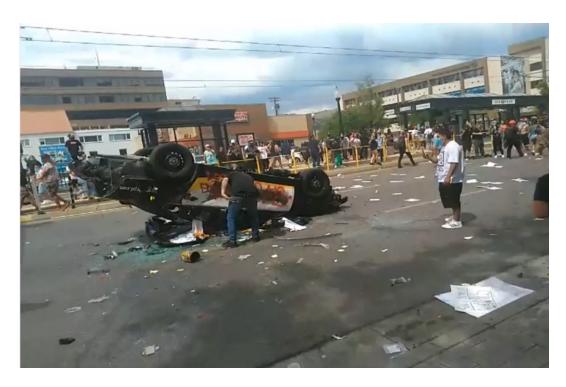
Image 5: Burning material and individual spray-painting side of vehicle. Screenshot from Juniper Toxic video.

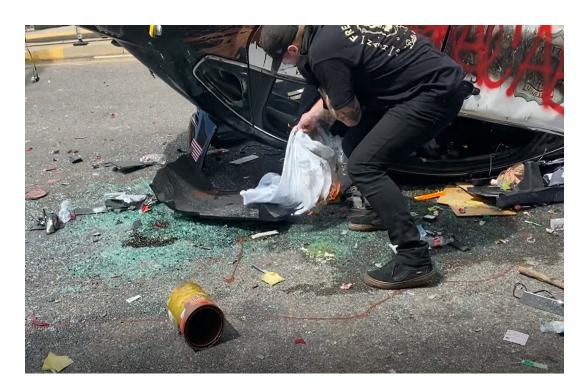
Image 7: Mr. Patton moving and piling burning material with a small amount of flames inside vehicle. Screenshot from Juniper Toxic video.

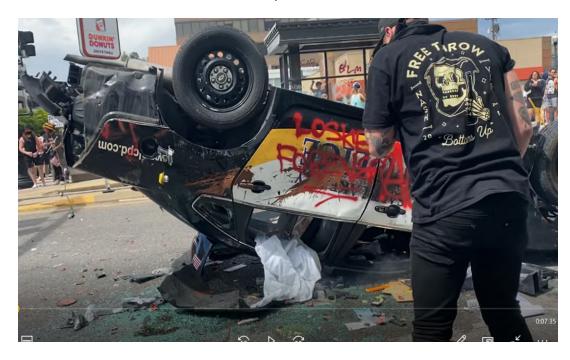
Image 8: White material after being moved with a small amount of flames inside vehicle. Screenshot from Juniper Toxic video.

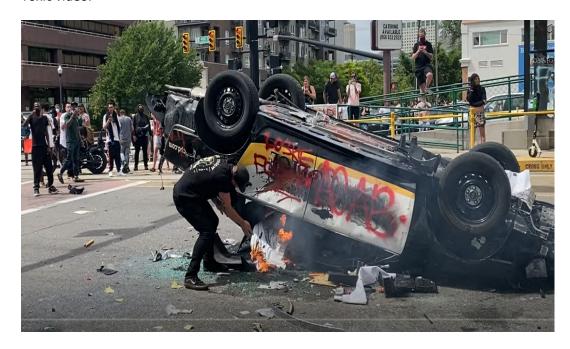
was burning inside the vehicle. Several seconds passed before the pile of white material began to burn more freely. Mr. Patton picked up a one-gallon Glidden's paint can from the street and threw some liquid from inside the can onto the white material. He then threw the paint can into the vehicle. The fire decreased in intensity a short time later. After Mr. Patton walked away, another individual threw a rolled up poster into the vehicle. Another individual threw a traffic cone toward the vehicle. After several minutes, the fire's intensity grew. Mr. Patton was not observed near the vehicle when the fire's intensity increased.

Image 10: Mr. Patton pouring brown material onto burning material. Screenshot from Juniper Toxic video.

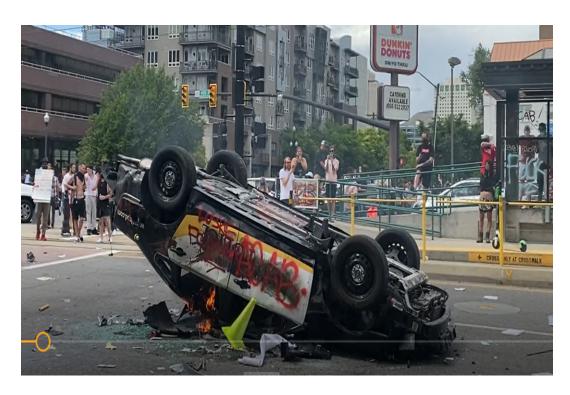
Image 11: Burning material in and near vehicle. Traffic cone thrown next to vehicle by an individual. Screenshot from video from Giovanni.

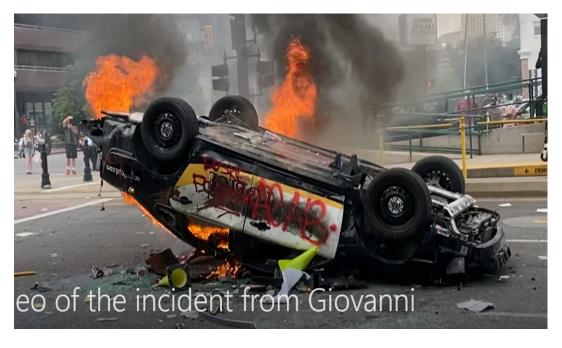
Image 12: Increased intensity of fire and additional traffic cone thrown next to vehicle.
